Manhole Inspection Summary

Manhole # S05UU1017MH

Insp Date: **9/6/06 9:29 AM**

Location Address: **3500 W NORTHERN PKWY**

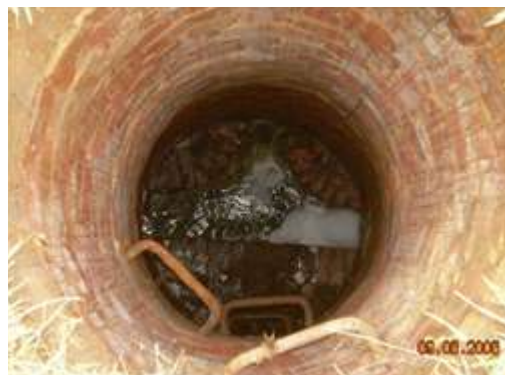
Top View

Adjustment, Corbel and Barrel infiltration.
Evidence of surcharge - Bench debris.
Corroded steps.

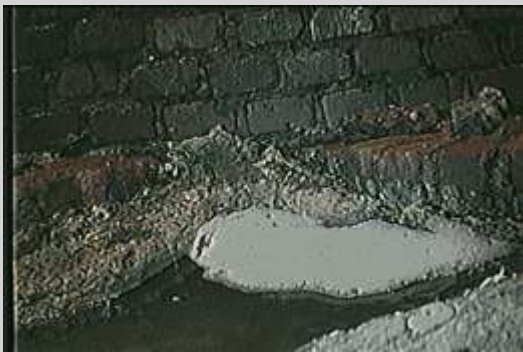
8 in. Circular Gravity Sewer Pipe Out @ 12 O'Clock

Barrel deterioration and infiltration. Channel debris. Bench deterioration.

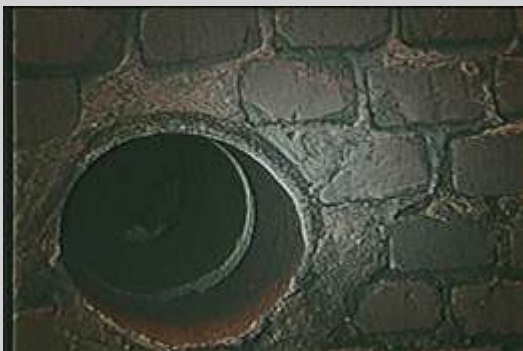
8 in. Circular Gravity Sewer Pipe In @ 3 O'Clock

Barrel deterioration and infiltration.

Infiltration: **Evidence** Pipe Seal Cond: **Unknown**

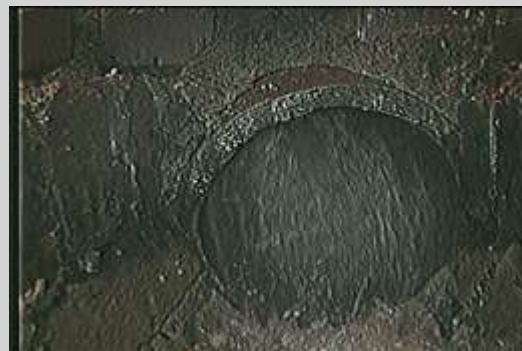
Drop In @ 3 O'Clock

Barrel deterioration and infiltration. Channel deterioration.

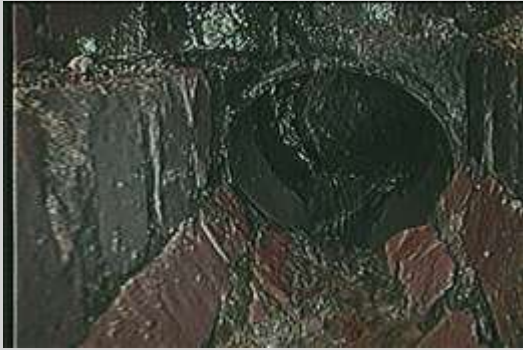
Pipe In @ 9 O'Clock

Barrel deterioration and infiltration. Channel deterioration.

Deposits: ☐ None ☐ Mud ☐ Sludge ☒ **Debris** ☐ Grease

Silt Depth: **0** (in.) Deposits Extent: **Light**
